ARCHÆOLOGICAL SURVEY OF INDIA

ANNUAL REPORT

1921-22

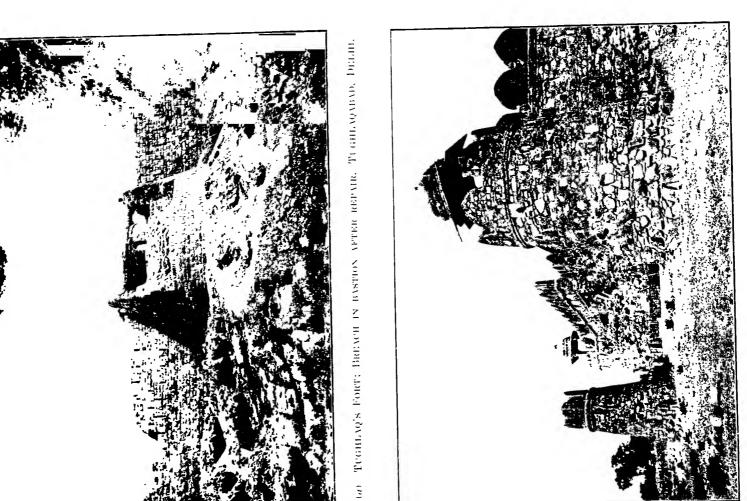
(b) TUGHLAQ'S FORT, SECOND GATEMAY SHOWING CHABITRA AND GATE AFTER REPAIR AND CLEMEANCE, TUGHLARMEND, DEBHIL

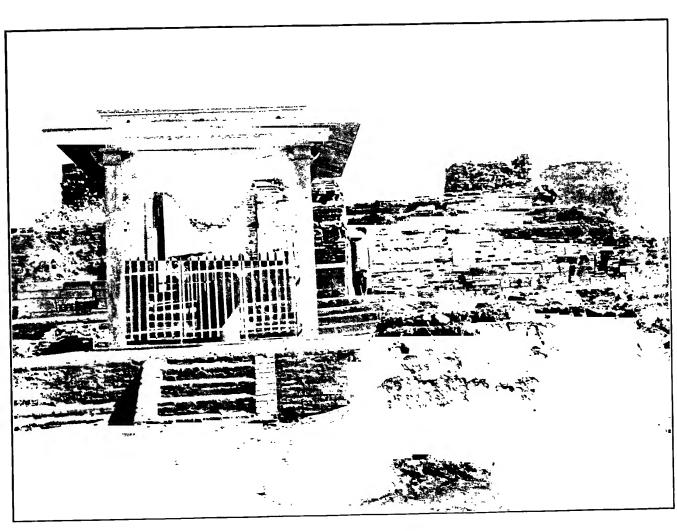
SOLTH-WEST WALL OF QADAN SHARIF UNDER REPAIR QADAN SHARIF, DELHI,

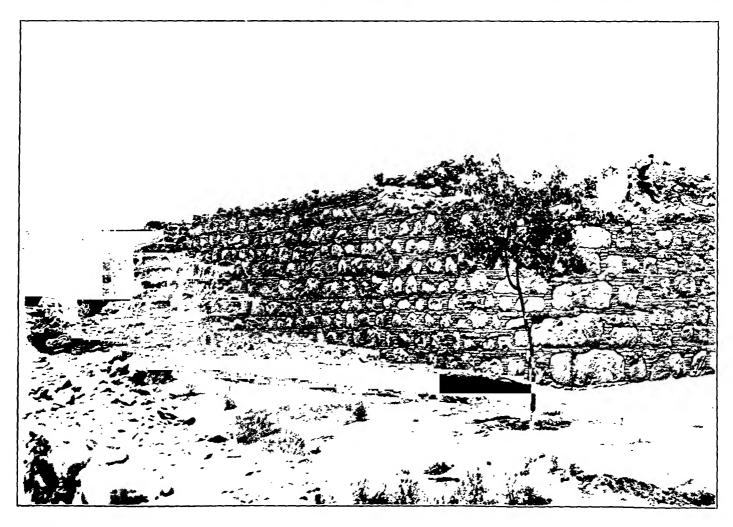
(a) JAULIAN MONASTERY. WEST WALL BEFORE CONSERVATION

The stones were numbered with chalk, and the walls photographed in sections before being dismantled. After dismantling, the back of each stone was numbered with coal-tar, and the stones arranged in order, ready for replacement. By means of the photographs the restoration of the stones to their original positions was rendered comparatively easy. The top course of the walls was set in time mortar to render them watertight. The condition of the walls after conservation may be seen from figure b of Plate V.

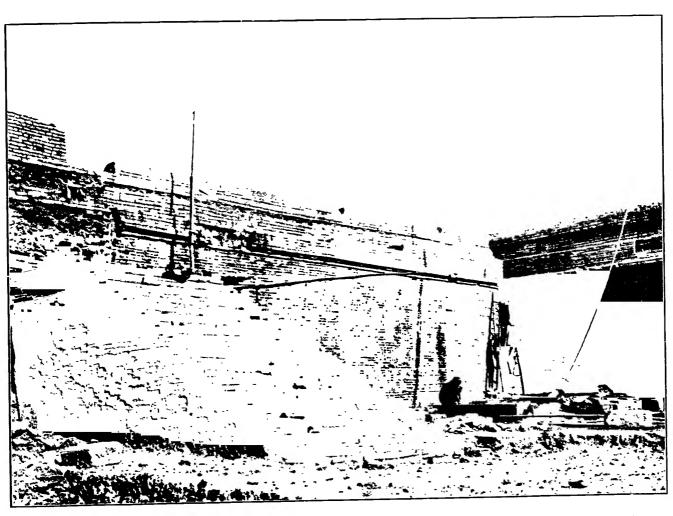
(b) JAULIAN MONASTERY WEST WALL AFTER CONSERVATION.

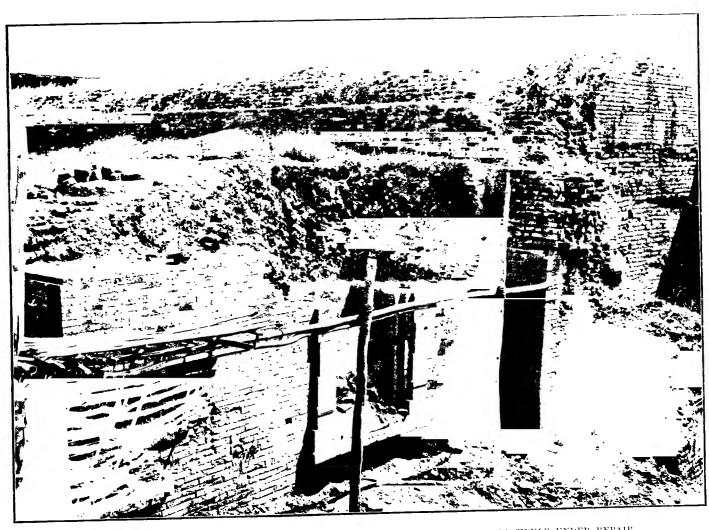
(b) Nalanda Monastery No. 1. Main western gateway before repair

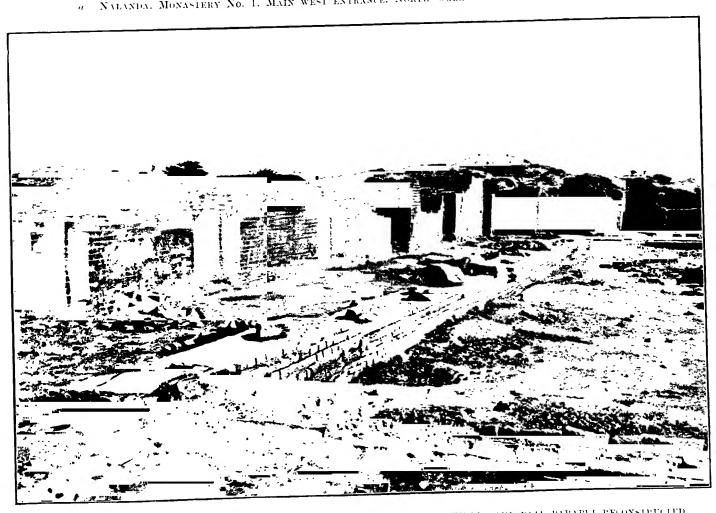
a Nalanda, Monastery No. 1. Main west entrance. North wall of vestibule under repair.

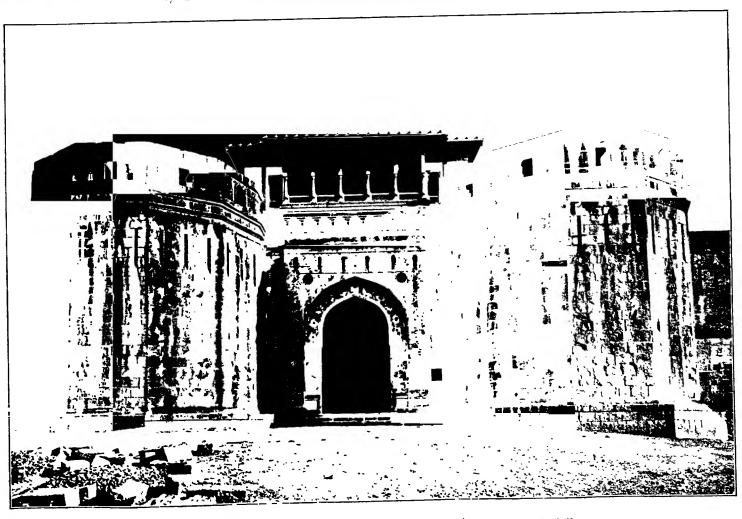
(a) Front of Delhi Gate, Shanwarwada, Poona, Before conservation.

"At Shanwar Wada in Poona City His Excellency the Governor of Bombay paved Poona. the way for effecting certain urgently needed restorations and repairs by raising subscriptions. The Delhi Gate, or the main entrance to the palace of the Peshwas, was being used by the Department of Land Records as one of its attached offices (Plate XIII). These offices were removed according to the orders of His Excellency, and the old Naqqarkhana on the top was restored to its former condition by paving it with stone, removing modern additions and alterations and clearing whitewash. The railing on the southern face of this fine Naqqarkhana had been demolished when the Land Records Office was placed in it and could not be found, but this difficulty was rectified by removing a portion of a similar carved wooden railing from a palace nearby, called Konkar's Wada, which belonged to one of the nobles of the Peshwas. The removal of this carved wooden railing from Konkar's palace to the Naqqarkhana of the Shanwar Wada Palace was kindly approved by His Excellency. The pavement of the ground floor inside the gateway was renewed at places, and a fine series of fresco paintings on the walls of the ground floor was revealed after the removal of coats of whitewash applied over these paintings. These frescoes belong to the early eighteenth century and possess a marked affinity to the Raiput School of painting. The subjects depicted can be recognised even now. On the northern wall of the southern portion of the main gate we find Vishnu lying on Sesha, Ganesa and Brahma, and on the side walls the ten incarnations of Vishnu and some incidents from the life of Krishna. From the money raised by His Excellency from the Ruling

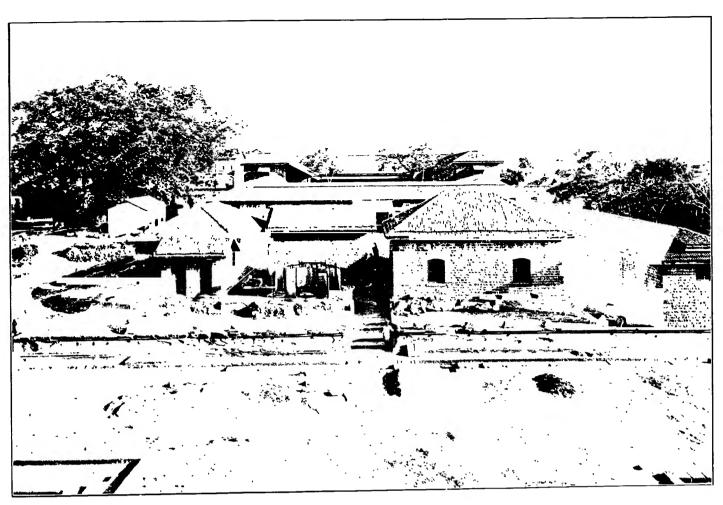
(b) -Front of Delhi Gate, Shanwarwada, Poona, After conservation.

Westers Circle. Chiefs of India the northern part of the garden in the interior of the walled enclosure of the palace was repaired and restored. The ancient stone paved way from the Delhi Gate to the terrace in front of the main building was repaved. The retaining wall on the northern, eastern and western sides of this terrace was rebuilt up to its original height, and the area turned into a grass plot. This terrace contained two cisterns with copper fountains in it. The copper fountains could not be restored in time for the Prince of Wales' visit though the water supply is still adequate to make them run. The main starcase leading from this terrace to the first court of the palace was repaired by renewing missing treads, and the plinth of the interior of the first court was repaired wherever stones were found to be missing (Plate XIV). Similarly a small court to the west of the first court of the palace was also repaired, enabling people to go through the first court to the small court. and then to the court of the thousand fountains, discovered during the previous year. The terrace-garden along the eastern wall was partly repaired. An ancient staircase leading from the first terrace in this area to the second was rebuilt, and portions of the stone fountains in the second terrace were replaced in position. In all Rs. 18,000 were spent from the funds raised by His Excellency the Governor, by subscriptions among the Ruling Chiefs for repairs to this portion of the Shanwar Wada palace, and Rs. 10.800 spent on urgently needed repairs to the inner walls of this fortress. The walls had collapsed at certain places and at other places were on the verge of collapsing. All of these portions were repaired on the lines of the old construction. All of these repairs were carried out before the visit of H. R. H. the Prince of Wales to the Shanwar Palace on the 19th November 1921. Expenditure on current repairs and maintenance to the Shanwar Wada, including the pay of the Police guard, amounted to Rs. 1.665.
